The use of RESIBLOCK '22' in Discrete Element Pavement Systems

John Knapton BSc.PhD.C.Eng.FICE.FIHT.M.Cons.E.
Professor of Structural Engineering, University of Newcastle upon Tyne

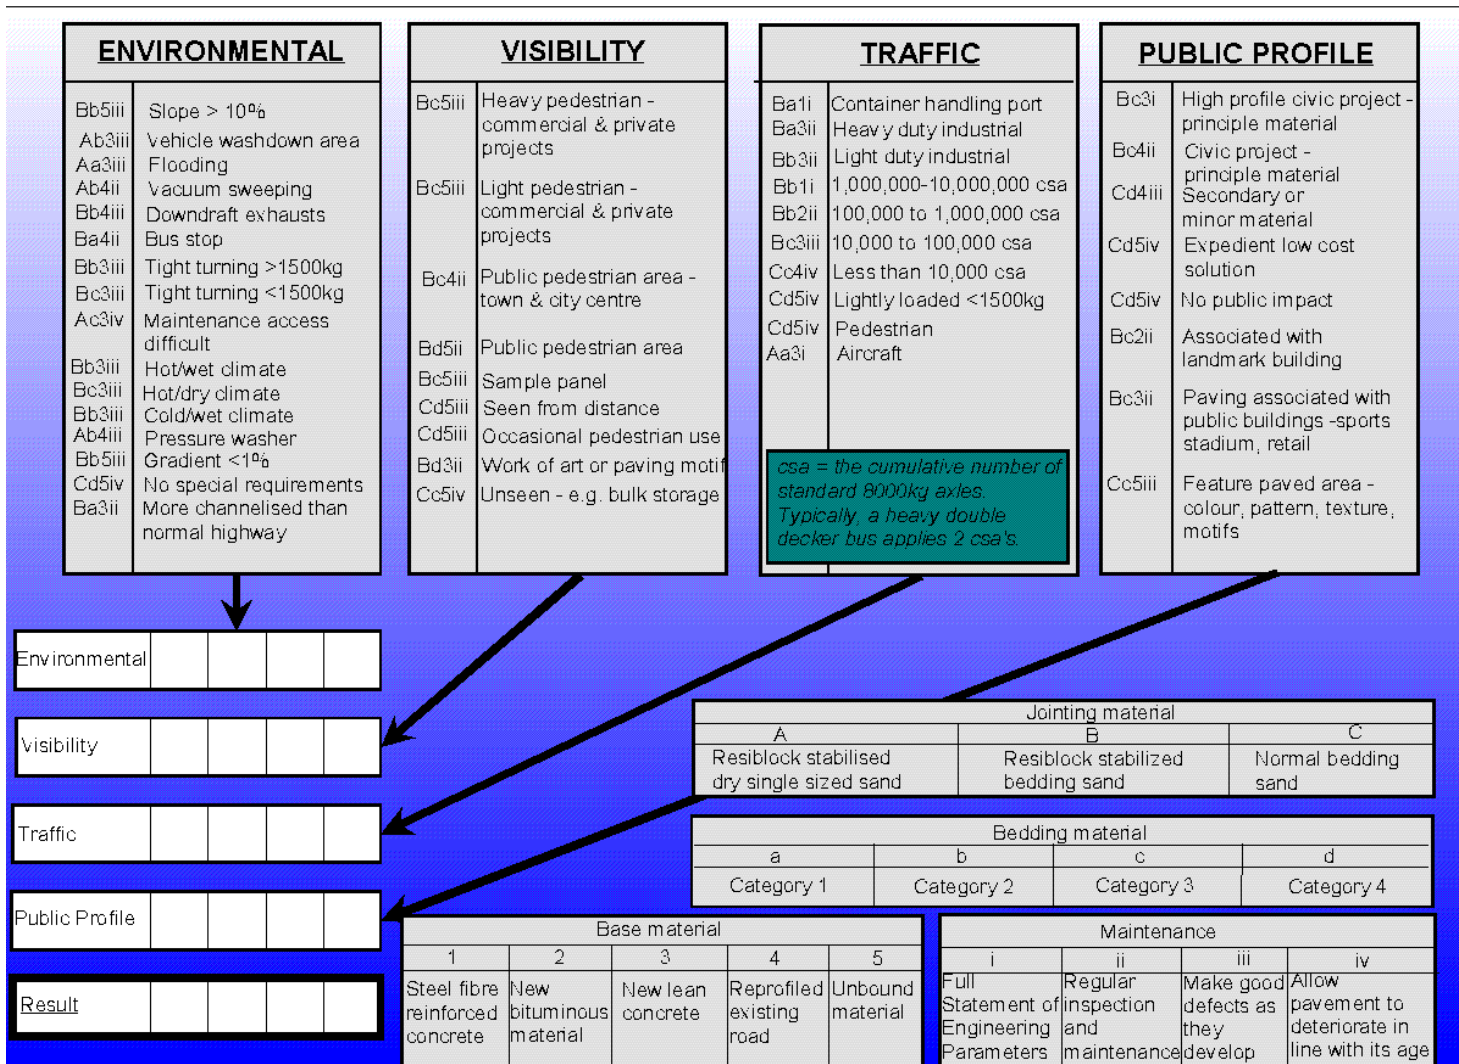
The Total Quality Chart is shown as Fig. 26. Each of the four Issue categories includes a series of factors which fall within that Issue. The user can select those factors which apply to the project in hand - there may be more than one in each Issue box. Each factor has a four element code such as **Bc4ii**. In this code, the upper case letter, **B**, refers to one of three jointing materials. The lower case letter, **c** refers to the category of bedding sand. The Arabic number, **4**, refers to the base material and the Roman numeral, **ii**, refers to the maintenance regime. For each of the four Issues, the user finds the code which is most onerous and transfers it to the appropriate box at the bottom left of the Chart. Once each of the four boxes is filled, the most adverse value of each element is transferred to the Result box. Hence the user can select the appropriate jointing material, bedding material, base material and maintenance regime. These four factors have been shown to be the crucial ones in long term pavement performance. Providing the data upon which the user bases his judgements is accurate, the Chart will ensure that the correct solution is produced. The user will then be able to focus upon developing the requisite specifications in detail.
