Erosion of Jointing Sand from Concrete Block Paving

John A. Emery, BA (Hons), C.Eng., MICE, FIHT, MASCE

From: Proceedings of 4th International Conference on Concrete Block Paving
– University of Auckland, New Zealand. February 16-19, 1992.

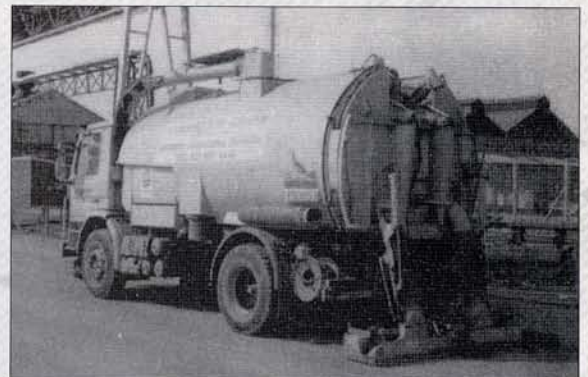
Many large areas of block paving are kept clean by the use of powerful cleaners and vacuum sweepers. If these are used before the joints in the block paving have become 'sealed' then there can be a serious loss of jointing sand and hence, loss of 'interlock'. It is difficult to quantify the forces involved in this form of erosion. Although not as severe as jet engine exhaust conditions, they are, nonetheless, substantial. The 'Frimokar' suction sweeper/cleaner shown in Figure 1 has a high pressure water jetting action operating at 40 MPa, and a suction of air velocity of approx. 60 m/s.

Figure 1. "Suction Sweeper/Cleaner"

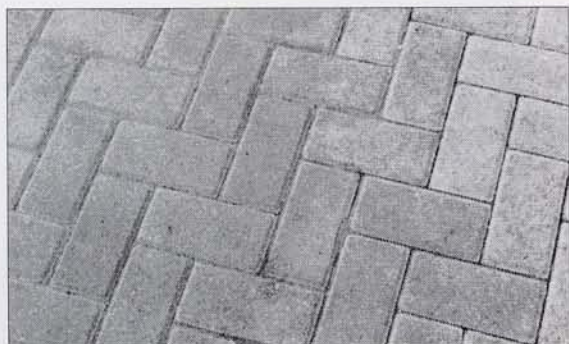
The polymer stabiliser previously described is performing satisfactorily after being in use for 5 years. Its effectiveness in stabilising jointing sand may be seen in Figure 2, which shows an area of aircraft pavement subject to jet blast, part of which has been treated with the polymer stabiliser. The noticeable absence of sand in the joints makes the untreated area obvious. The method of application of the polymer is indicated in Figure 3. It is applied direct from its container and spread by brooms or squeegees. Any excess material remaining on the surface of blocks is removed by the use of plastic foam rollers.

Figure 2. Aircraft Pavement Partially Treated with Polymer

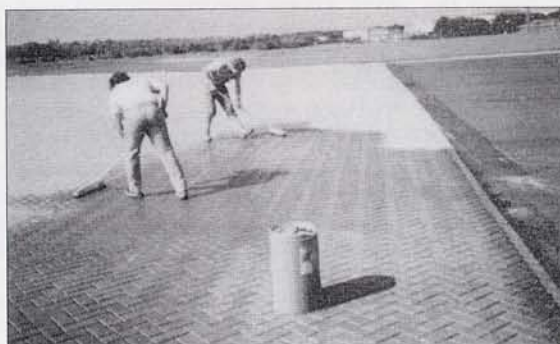
Figure 3. Applying Polymer Stabilisers

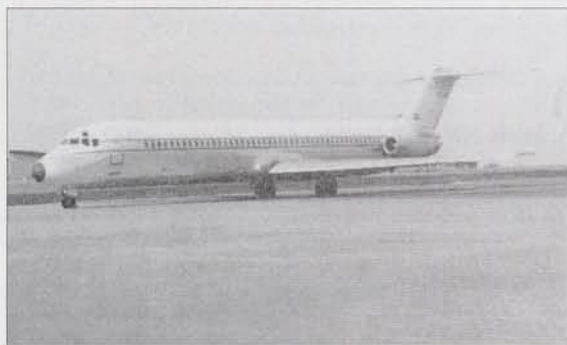
Figure 4 shows a turning circle at one of the runway ends at Luton International Airport which is subject to frequent movement of aircraft at full take-off thrust. To date, aircraft pavements surfaced with concrete blocks, have been treated with the polymer stabiliser, at 10 airports in the UK and overseas.

Figure 4. Aircraft Pavement – Runway Turning and Take-off Area
