EFFLORESCENCE

– *prevention is better than cure*

John Bensted, Consultant in Cement Technology and Visiting Professor in the School of Crystallography, Birkbeck College, University of London

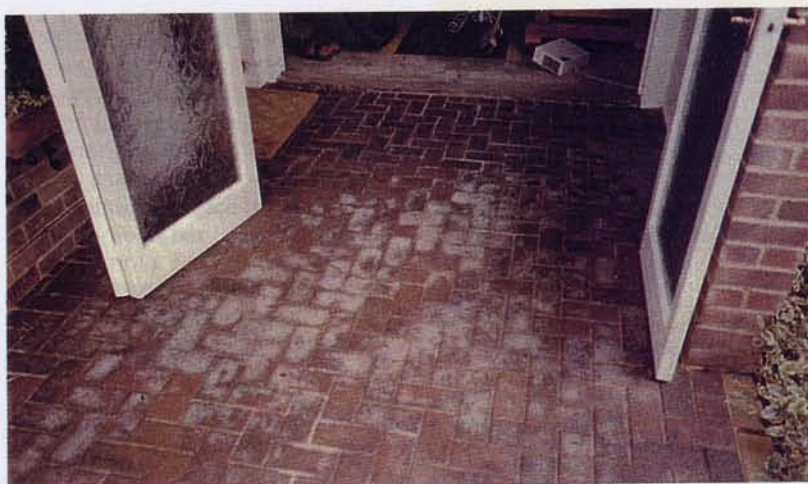
Figure 1: The unsightly effects of efflorescence on a domestic driveway/path.

Efflorescence is ugly but not normally damaging to the exposed concrete or brickwork⁽⁴⁾. Figure 1 illustrates the effect of efflorescence on a domestic driveway/path. However, on rare occasions, the leaching effects of efflorescence may be enough to cause residual damage to the structure. Should structural integrity be in doubt, the situation should be clarified by expert inspection.

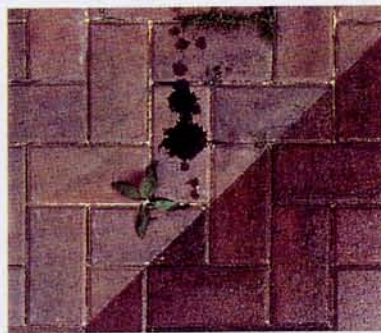
Figure 2: Contrast between untreated blockwork and blockwork treated with a polyurethane-based preparation.

Figure 2 shows the difference between untreated blockwork and blockwork treated with a polyurethane-based system.
